Manhole Inspection Summary

Manhole # S51W1_002MH

Insp Date: **5/29/08 10:21 AM**

Location Address: **1901 Chesapeake Ave.**

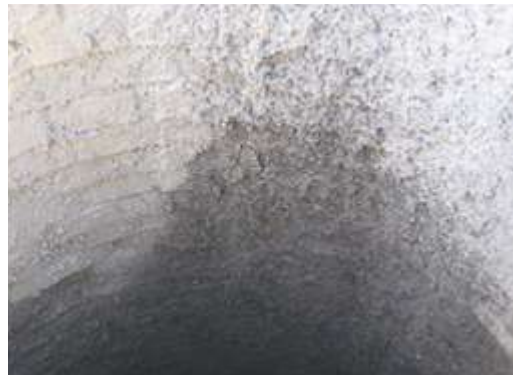
Defect 2

Infiltration: ☐ None ☐ Joint ☐ Cracks ☐ Mortar ☐ Roots ☒ **Wall**

Infiltration through the wall

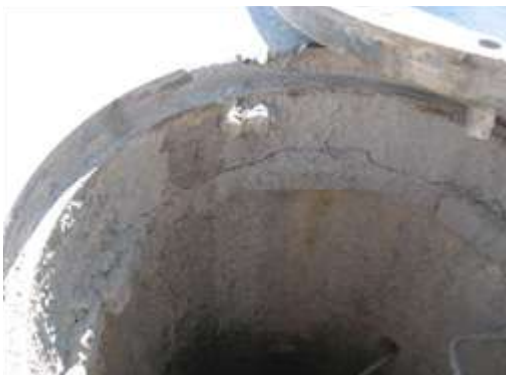
Defect 1

Condition: ☐ Sound ☒ **Cracked** ☐ Leaks

Broken Frame

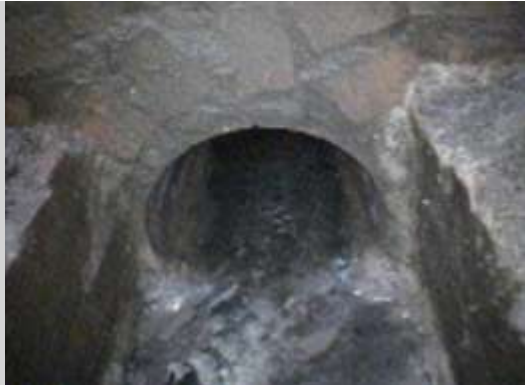
12 O'Clock Outflow

10 in. Circular Gravity Sewer
Pipe Out @ 12 O'Clock

Pipe Height: **10.8** (in.) Rod and Bar (Angled)
Pipe Material: **Clay** ☐ Pipe Lined
Invert Depth: **12.70** (ft.) Flow Characteristics: **Fast**
Deposits: ☒ None ☐ Mud ☐ Gravy ☐ Debris ☐ Grease
Silt Depth: (in.) Deposits Extent:
Infiltration: **None** Pipe Seal Cond: **Sound**

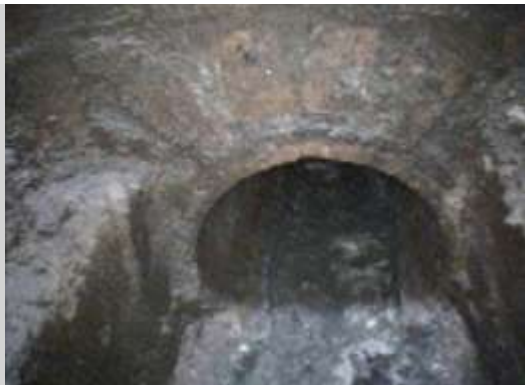
6 O'Clock Inflow

10 in. Circular Gravity Sewer
Pipe In @ 6 O'Clock

Pipe Height: **10.8** (in.) Rod and Bar (Angled)
Pipe Material: **Clay** ☐ Pipe Lined
Invert Depth: **12.54** (ft.) Flow Characteristics: **Fast**
Deposits: ☐ None ☐ Mud ☒ Gravy ☐ Debris ☐ Grease
Silt Depth: **2** (in.) Deposits Extent: **Light**
Infiltration: **None** Pipe Seal Cond: **Sound**
